Survey # WA-II-1084 Approximate date <u>Ca. 1880</u>
Street Address 80 South Main Street
Town, State Keedysville, Maryland
private <u>X</u>, public ____

MARYLAND COMPREHENSIVE HISTORIC PRESERVATION PLAN DATA

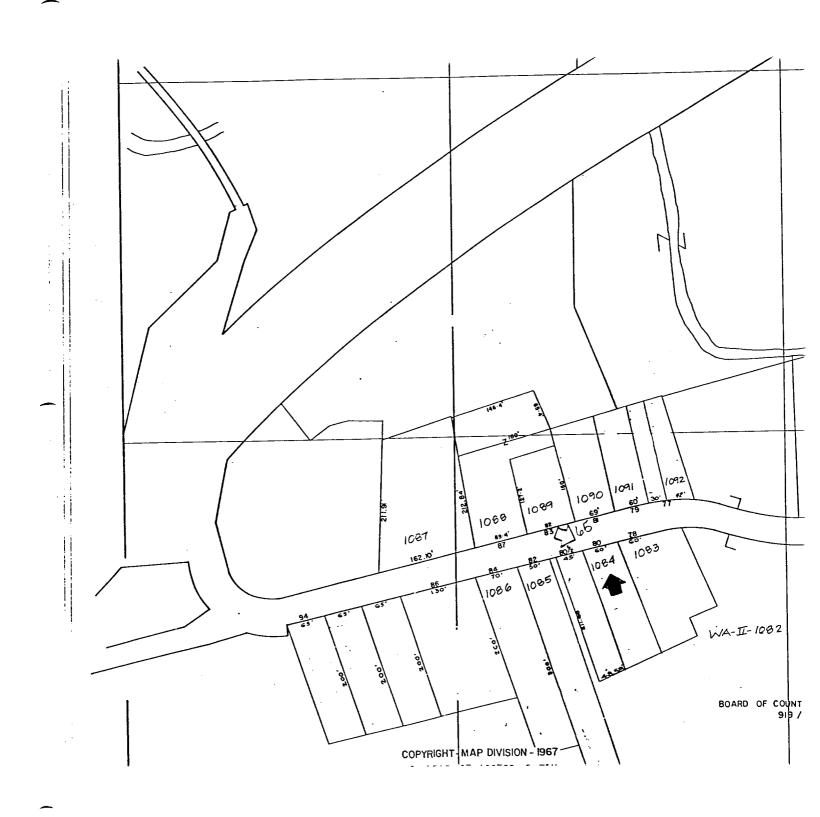
Photo Reference: Photo # 65

This brick house dates from after 1877 since it does not appear on the Atlas map of that year. It is a one and a half story, three bay brick structure with a central entrance. Windows have shingle pane sash with the three second story windows having a single sash beneath wide wood lintels. The main entrance is located in the center bay and it includes a narrow transom above the door. A porch across the front has had its posts replaced.
